MCBREEN ENVIRO UK TACKLES INFILTRATION CHALLENGES WITH K-PREMA INTERNAL PIPE SEAL

GLOUCESTER

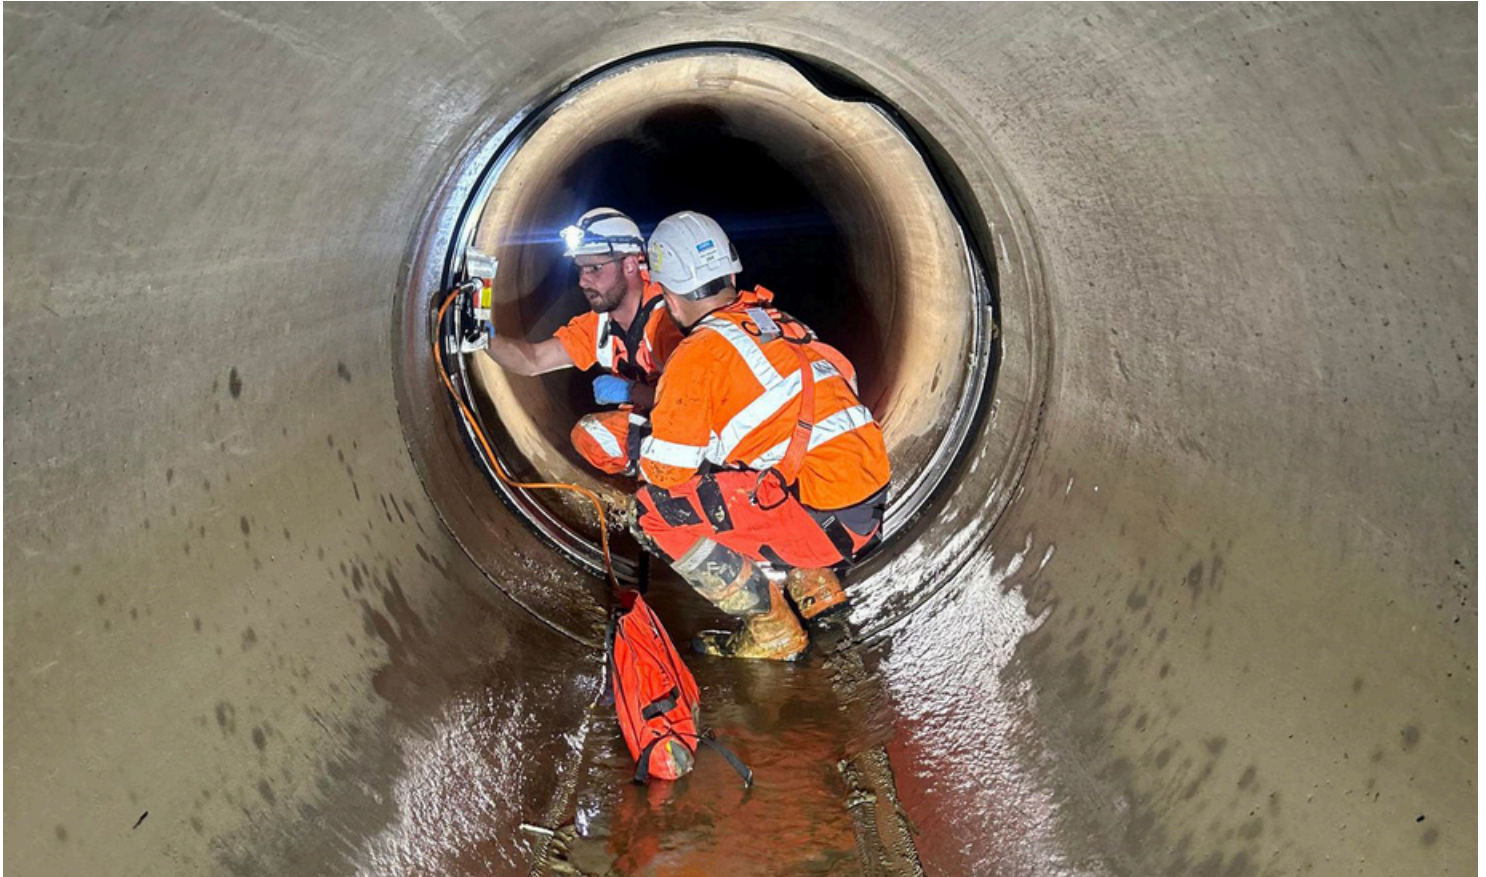
- Groundwater infiltration in a newly installed, unconnected sewer network
- The network, consisting of 120-meter-long sections of 1500mm diameter concrete pipes, was experiencing rapid water ingress, threatening the integrity and functionality of the new drainage system
- CCTV drain survey confirmed groundwater infiltration at several joints along the network

A comprehensive CCTV drain survey confirmed groundwater infiltration at several joints along the network, which was promptly communicated to the client.

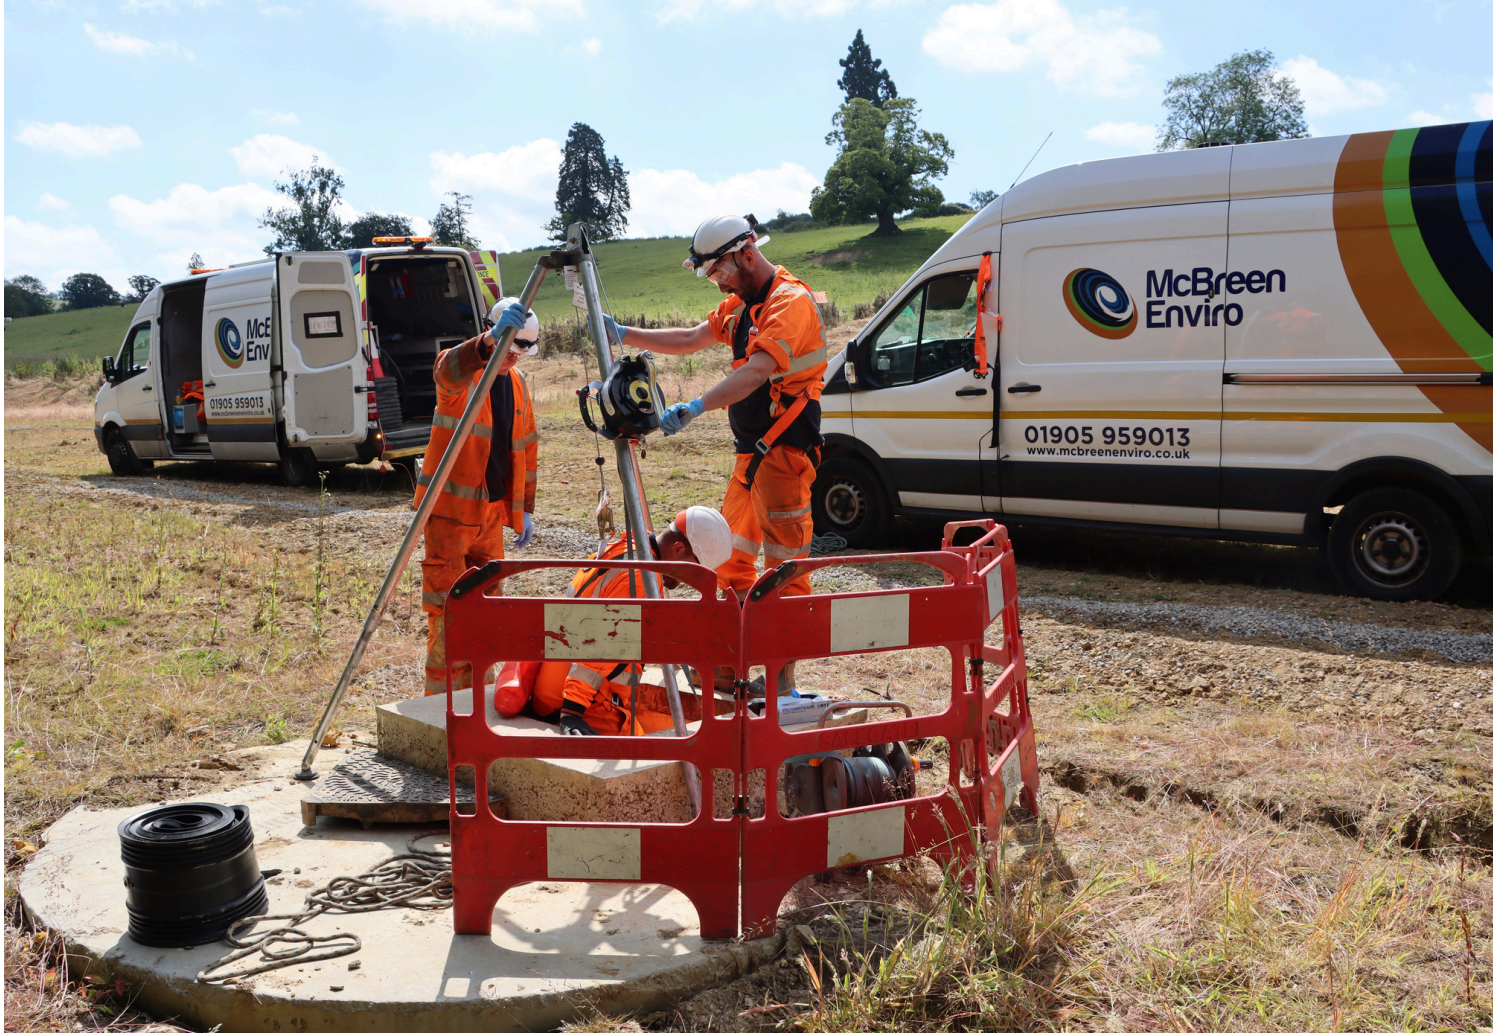
- The K-Prema Internal Pipe Seal System is a mechanical sealing solution for pipe sections that utilises trenchless installation methods
- Suitable for a range of large diameter pipes; the K-Prema mechanical seal can be used on an array of pipe materials
- Withstanding internal pressures of up to 20 bar, the K-Prema seal provides a reliable solution for sealing infiltration points and preventing future leaks

Collaborating with S1E Ltd, specialist suppliers of trenchless technology, the team opted for mechanical pipe seals from the K-Prema range. The K-Prema Internal Pipe Seal System includes a large EPDM rubber sleeve and retaining clamping bands made of high-grade 304 stainless steel. This system is suitable for various applications, including sewage, water, oil, and air.

After meticulous cleaning and preparation of the pipe, our technicians undertook a challenging 60m ascent to the infiltration points within the massive 1500mm diameter concrete pipe.

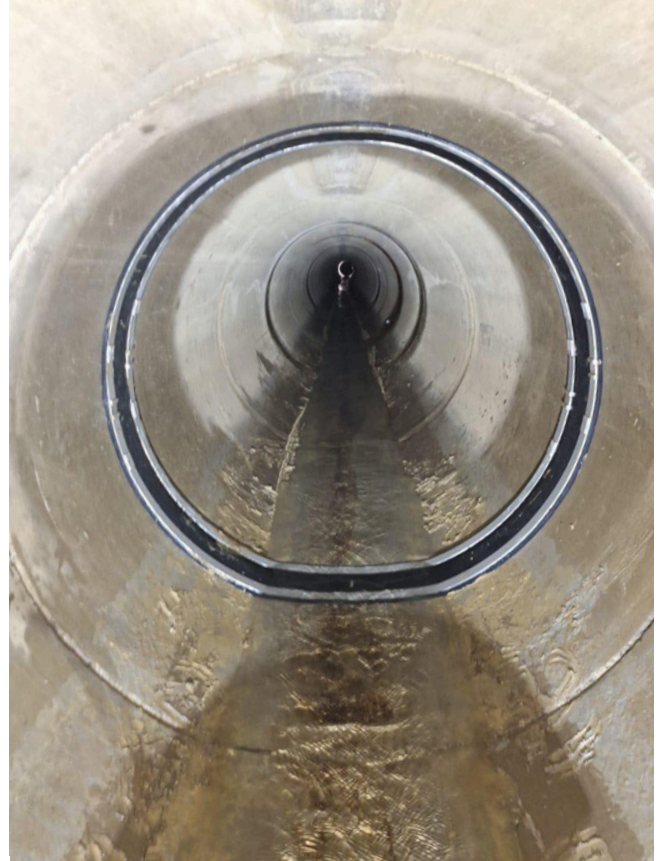
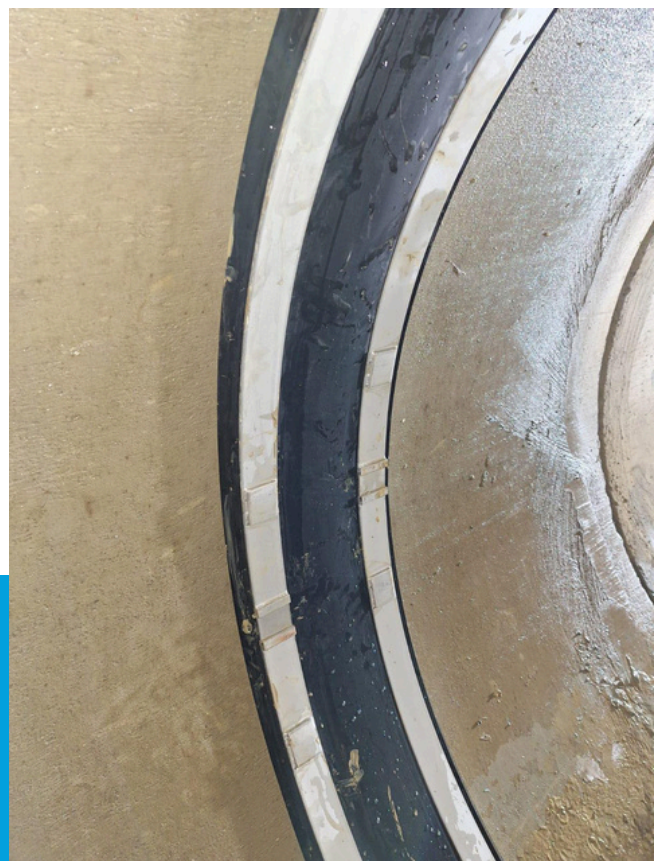
Despite the large pipe diameter and long pipe lengths, the team successfully installed six 1500mm internal mechanical pipe seals. The K-Prema solution minimised system disruption and avoided extensive excavation. It was significantly more cost-effective than traditional repair methods, meeting the client's budget constraints.
