CASE STUDY

SUCCESSFUL ATTENUATION POND CLEANING AND RELINING PROJECT

NORTH DUBLIN

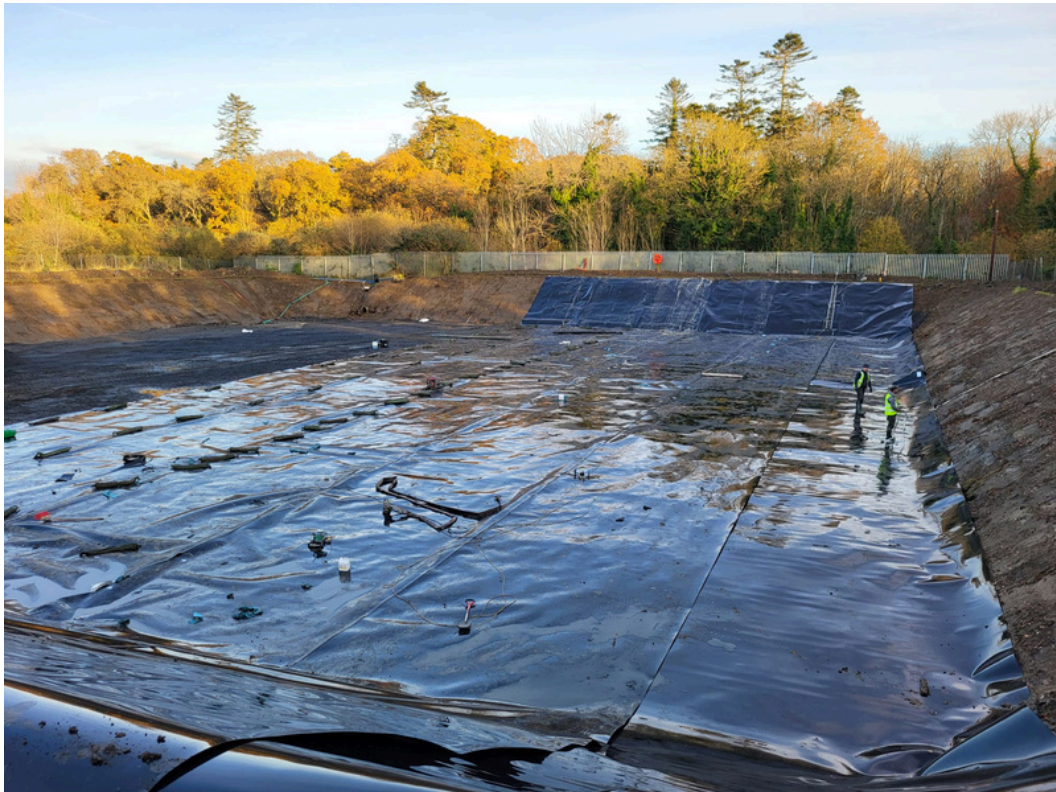
Once the pond was thoroughly cleaned, our team proceeded with the installation of the 2mm HDPE liner using advanced Leister welding equipment. This liner was crucial for ensuring that the pond could effectively manage floodwater in the future.
