# CASE STUDY

## S1E AND MCBREEN ENVIRO UK COLLABORATE TO RESOLVE PIPE INFILTRATION AT THE A30 MAMMAL CROSSING

## Effective Solutions with K-Prema Mechanical Seals

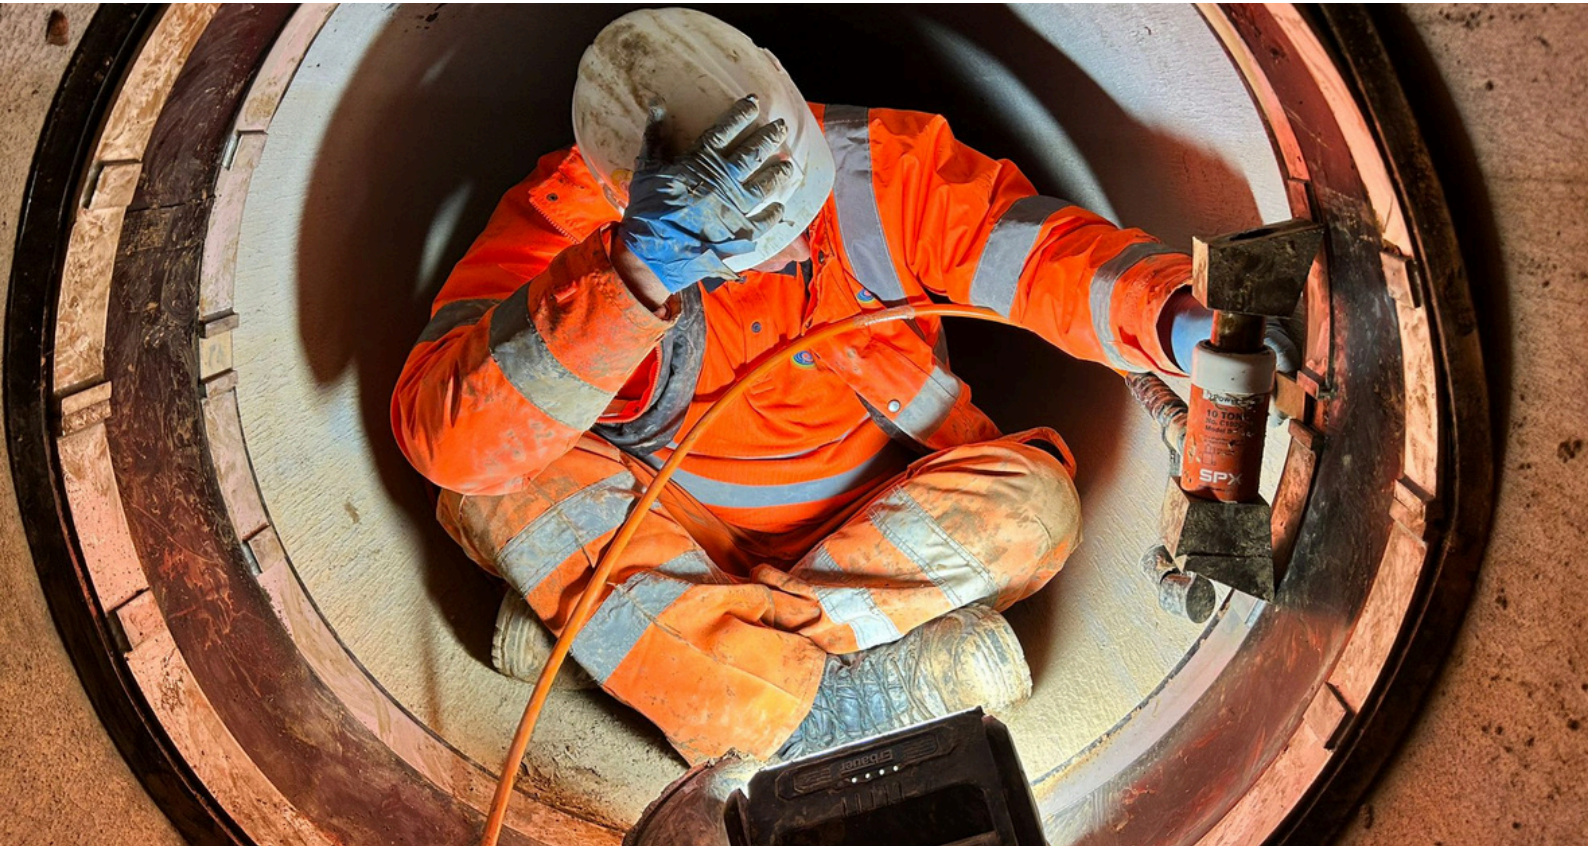
- The project aimed to eliminate groundwater infiltration in a 900mm diameter concrete pipe under the A30 roadway, an essential mammal crossing allowing wildlife to safely cross this busy section of the Chiverton to Carland Cross route in Cornwall.

- Severe Groundwater Infiltration: Affected 40 segments of the pipe (18 in one section and 22 in another).
- Wildlife Protection: Required minimal disruption to preserve safe animal passage.
- Safety Requirements: Demanded a skilled team trained in confined space operations and rescue and recovery.

S1E was consulted for a reliable repair solution and recommended McBreen Enviro UK for their expertise. The K-Prema Mechanical Seals were chosen for their durability and effectiveness in preventing water ingress.

The seals were applied strategically to reinforce the 900mm pipe and halt infiltration, ensuring long-term functionality.

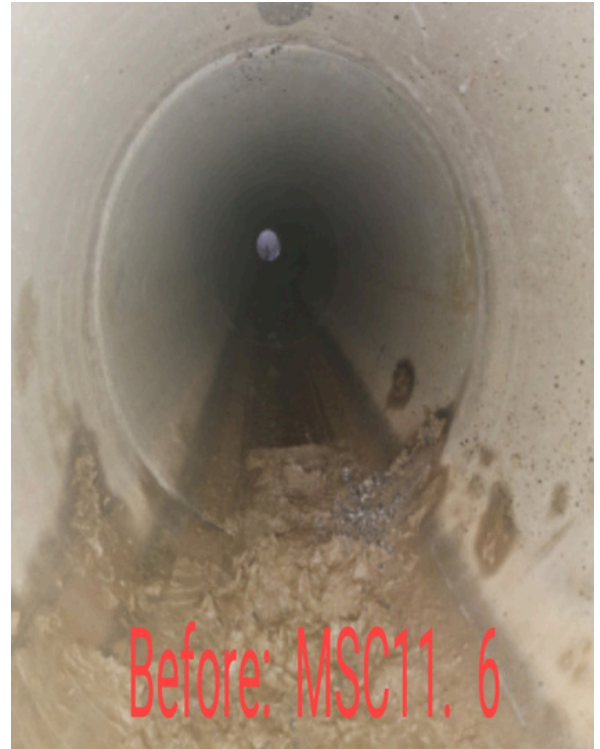
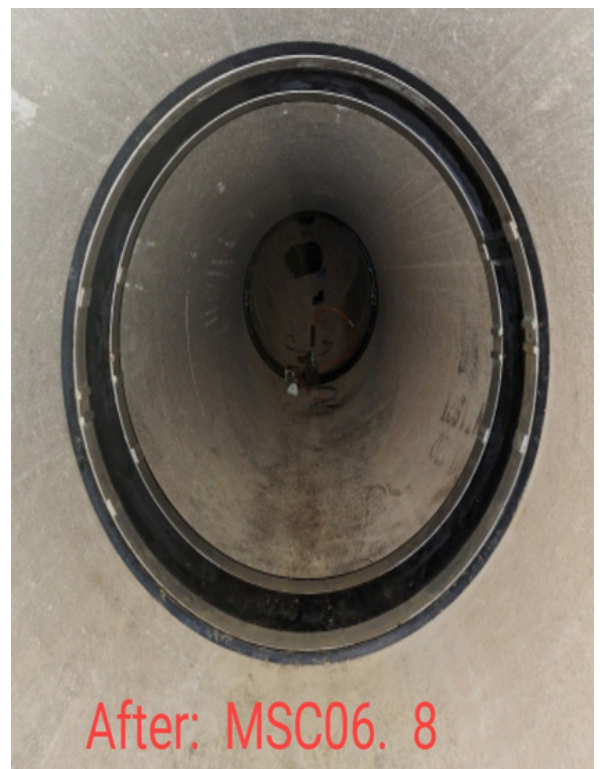
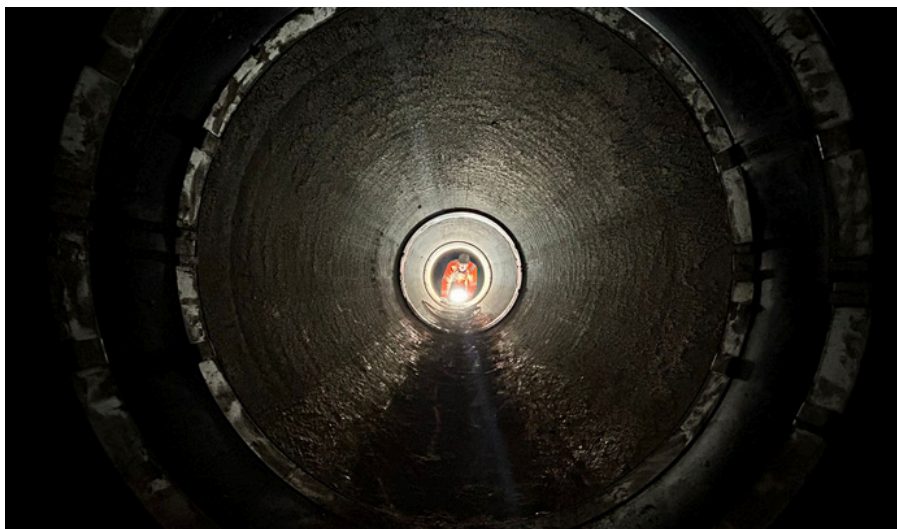
- **Successful Infiltration Mitigation:** The K-Prema Mechanical Seals fully addressed the groundwater issue, sealing the pipe and preventing further water ingress.
- **Timely Project Completion:** Achieved within the set timeframe with minimal disruption.
- **Enhanced Infrastructure and Wildlife Conservation:** The repaired crossing now supports ongoing wildlife movement and roadway stability.

A team of McBreen Enviro UK specialists, certified in confined space work, installed the seals.
